# Condition survey and analysis of epoxy asphalt concrete pavement on Second Nanjing Yangtze River Bridge: a ten-year review

**Abstract:** To obtain a complete picture of the epoxy asphalt pavement condition on the Second Nanjing Yangtze River Bridge, an on-site survey is conducted to collect information regarding traffic composition and extents of pavement distresses. The survey shows that 30 m<sup>2</sup> out of the entire 3.8 × 10<sup>4</sup> m<sup>2</sup> pavement exhibits potholes and alligator cracks. Other surface cracks are also found, including regular longitudinal cracks, short hairline cracks, bubble cracks, and ring cracks. Rutting and shoving are not observed on the pavement. The causes of pavement distresses are discussed by analyzing the pavement mechanical response with actual traffic composition. Research results indicate that the regular longitudinal cracks occurring at ribs near wheelpaths are due to fatigue damage. Short hair cracking and bubble cracking are mainly related to construction defects. Alligator cracks are the results of the development of regular, short hair and bubble cracks lacking effective maintenance. Potholes are induced by the cracking and m

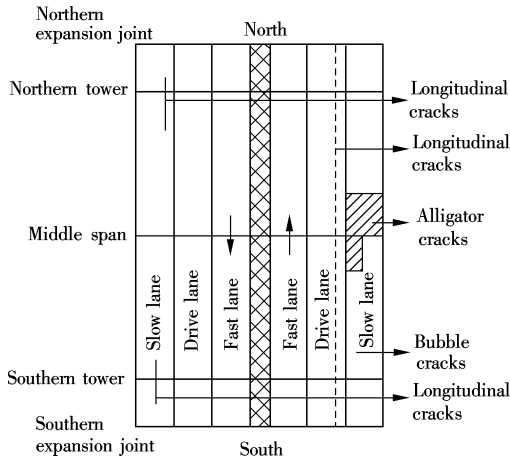
A condition survey of epoxy asphalt pavement on the SNYRB was conducted. The results, as illustrated in Fig. 1, show that the pavement on the two fast lanes is in good condition. The pavement on the northbound drive lane has some longitudinal regular cracks and short hairline cracks, while the pavement on the two slow lanes has potholes and irregular cracks including bubble cracks, ring cracks and alligator cracks. It is encouraging that no shoving or rutting distress was found on the entire epoxy asphalt pavement.

**Fig. 1** Types and distribution of pavement distresses on SNYRB

Among all the pavement distresses, about 95% of them were observed on the two slow lanes, with 85% of the distresses occurring on the northbound slow lane, and 10% occurring on the southbound slow lane.

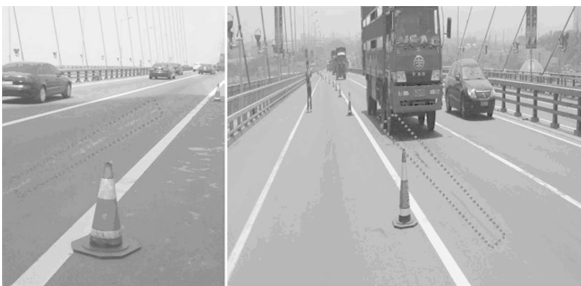
A regular crack is defined as a crack that is mostly caused by structural damage or thermal stress, and propagates longitudinally or transversely. Field investigation of the SNYRB pavement shows that regular longitudinal cracks occurred along the positions of deck stiffening ribs or girders, or in the truck wheel paths. One longitudinal crack was found crossing the whole bridge on top of one stiffening rib in the northbound drive lane, as shown in Fig. 2. Through the observation and investigation, the longitudinal crack was located upon the fatigue damage joint between the rib and deck. In the southbound slow lane, two longitudinal cracks were also observed, one in the center of the lane, and the other in the right wheel path, as shown in Fig. 3.

**Fig. 2** Longitudinal regular cracks in the northbound drive lane on SNYRB

3) Regular longitudinal cracks in the pavement generally occur along U ribs or stiffeners, where the maximum strain or stress in the pavement is located. Short hairline cracks are caused by construction defects. Bubble cracks are caused by moisture contamination from water dripping from towers or cables or from worker sweat during the paving process, and are unique distresses in epoxy asphalt pavement on steel bridge decks. At a later stage, ring cracks may appear around the bubble cracks. If the above cracks are not timely and properly sealed, serious distresses such as potholes and alligator cracks can develop from these cracks under the coupling action of repeated traffic loading and dynamic water pressure.

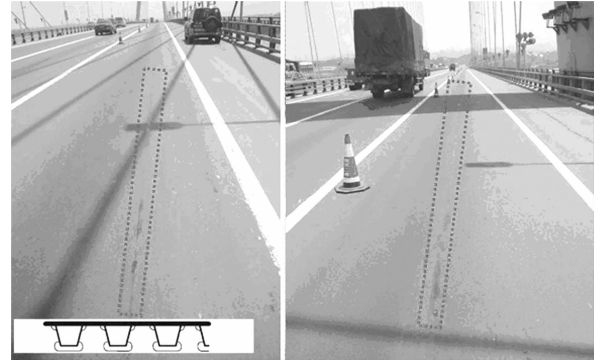
**Fig. 3** Longitudinal regular cracks in the southbound slow lane on SNYRB

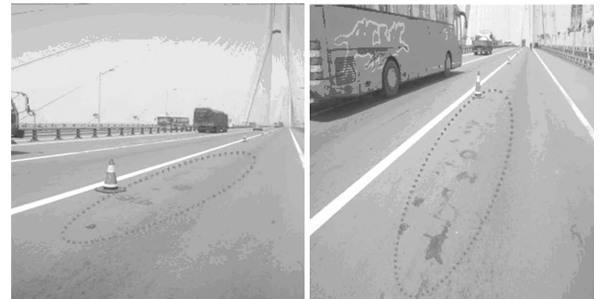
Short hairline cracks are defined as cracks with irregular shapes, a length less than 30 cm, a width less than 0.2 cm, and a depth less than 2 cm, as illustrated in Fig. 4. Short hairline cracks are mostly observed at the surface of epoxy asphalt pavement on steel bridges. On-site survey on the SNYRB reveals that the pavement in the northbound slow lane had dozens of short hairline cracks, most of which were located in the left wheel path from the southern expansion joint to the southern tower.

**Fig. 4** Short hairline cracks in the northbound slow lane on SNYRB

Short hairline cracks are typically caused by construction defects, and have nothing to do with asphalt mixture properties. If short hairline cracks are not sealed properly, they will develop into alligator cracks due to heavy traffic and environmental influences. The relationship between the initiation of short hairline cracks and the construction process needs further investigation to reduce the occurrence of this type of cracks.

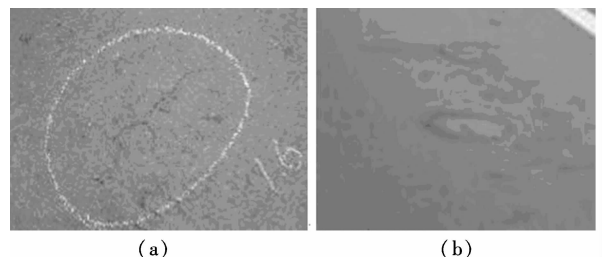
Bubble cracks are characterized with short radial cracks of about 15 cm in length in at least three directions, as shown in Fig. 5(a). Ring cracks shown in Fig. 5(b) appear around the radial cracks due to repeated wheel loading and dynamic water pressure. Based on the on-site investigation on the SNYRB, most of the bubble and ring cracks occurred in both the northbound slow lane and the northbound drive lane.

**Fig. 5** Bubble and ring cracks in epoxy asphalt pavement on SNYRB. (a) Bubble crack; (b) Ring cracks

Bubble cracks are caused by moisture introduced during the paving process. Sources of moisture include water dripping from bridge towers or cables, residual water on the deck after rain, and sweat from workers during paving. Such moisture contamination may exist on steel bridge decks paved with any type of asphalt mixture. However, it

is interesting to observe that bubble cracks only occur in epoxy asphalt pavements, while they have not been observed on steel bridges paved with other asphalt mixtures, such as Gussasphalt (with zero air-void content), polymer modified asphalt mixtures and stone mastic asphalt mixtures (with low air-void content). The reason is that the epoxy asphalt mixture is mixed and placed at temperatures much lower than other asphalt mixtures so that epoxy resin can cure at a slower rate to ensure sufficient construction time. Typical mixing and compaction temperatures for epoxy asphalt are around 120 and 110 °C, respectively. Such temperatures cannot guarantee complete evaporation of moisture residuals on the steel deck before the epoxy asphalt is placed and completely compacted. Therefore, moisture contamination should be strictly forbidden during the construction process of epoxy asphalt pavement.

Ring cracks always appear around bubble cracks due to repeated traffic loading and/or potential dynamic water pressure. If the non-regular cracks are not timely treated, alligator cracks will be finally formed.

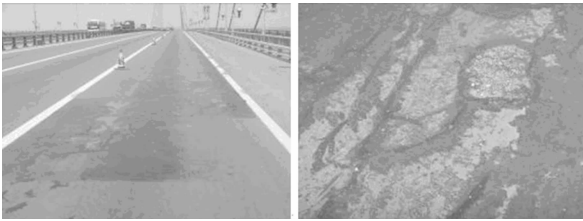
Some alligator cracks are found in the pavement on the SNYRB. The most serious alligator crack was located in the northbound slow lane at the span center of the bridge, the area of which was 20 m<sup>2</sup>, as shown in Fig. 6.

Fig. 6 Alligator crack in the northbound slow lane on SNYRB

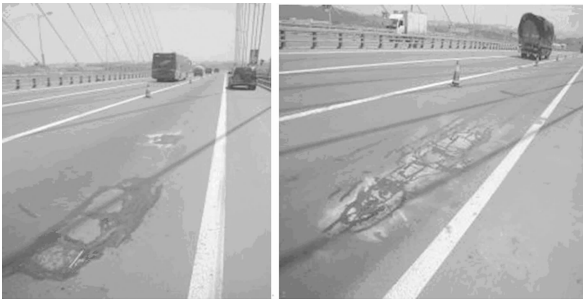
Another serious alligator crack occurred in the southbound slow lane at the span center between the southern tower and the southern expansion joint. As shown in Fig. 7, this alligator crack is also in the right wheel path.

Fig. 7 Alligator crack in the southbound slow lane on SNYRB

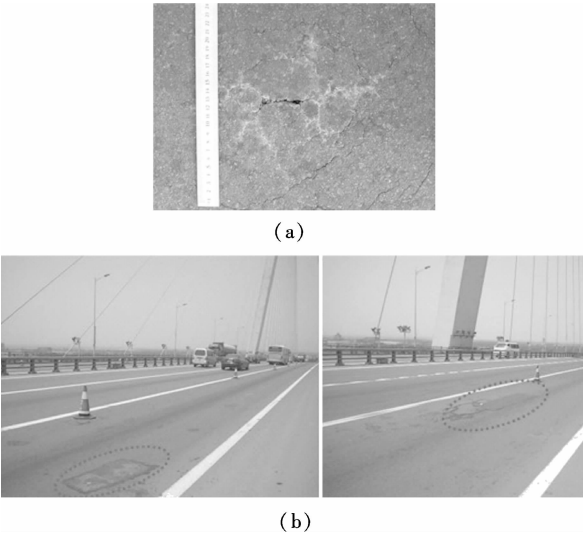
Potholes are developed from cracks under the coupling action of wheel loading and dynamic water pressure if the cracks are not sealed or patched in time. Long-term observation of epoxy asphalt pavement on the SNYRB shows that a pothole first occurred in the pavement in the form as shown in Fig. 8(a). Two potholes were found in the pavement on the northbound slow lane, and had been patched by

Fig. 8 Pothole in epoxy asphalt pavement on SNYRB. (a) Small pothole; (b) Patched pavement for two potholes

the maintenance crew of the bridge maintenance company. The distressed area is about 0.2 m<sup>2</sup> for one pothole, and about 2 m<sup>2</sup> for the other, as shown in Fig. 8(b). Moisture was trapped inside the potholes during the patching process, which later caused corrosion of the steel deck, as shown in Fig. 9.

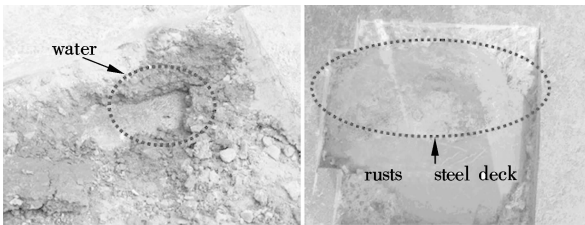
Fig. 9 Water remaining in the pavement and rust of the steel deck on NSYSB

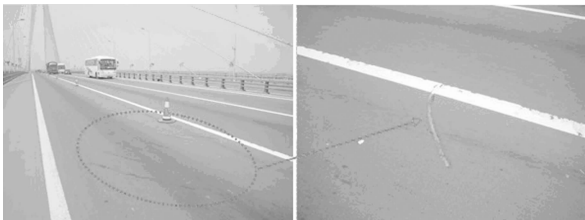
Other than the common pavement distresses above, accident distress was also found on the pavement on the SNYRB. A few scratches caused by the striking of falling objects from vehicles were observed in the slow lanes, as shown in Fig. 10.

Fig. 10 Scratching on epoxy asphalt pavement on SNYRB
