Exploration and preservation of Petra

Nawaf A. H Abu Skoot Gong Kai

(School of Architecture, Southeast University, Nanjing 210096, China)

Key words: urban revitalization; conservation; preservation

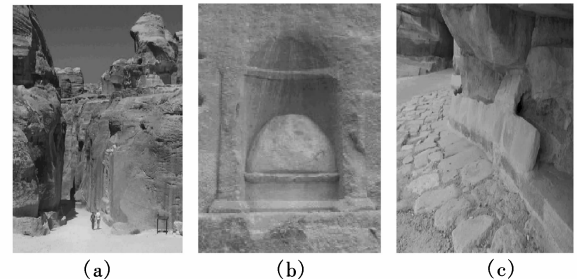
Fig. 2 Walls of the Siq. (a) The Siq leads to the Treasury; (b) Small niches; (c) Along the left side of the Siq, a covered water channel

with sculptures. The city also has its share of civic buildings since it was once a major cross-road for the caravan routes that led to Sinai, the Red Sea, the Dead Sea, Egypt and Syria. The climate, which appears to have changed little since ancient times, impelled the inhabitants to construct ingenious systems, veritable works of art, to control the water that nature dispensed with a parsimonious hand. Annual precipitation in the area averages between 50 and 250 millimeters a year, an amount characteristic of semi-desert regions. These climatological conditions, combined with the abandonment of the ancient system of dams and irrigation channels has been one of the causes of erosion of the soil and of the amplitude of the flooding when the area is at times subjected to torrential rain. Access to the site of Petra is through the narrow, two-kilometer-long Siq Gorge (see Fig. 2).

An initial solution could be the creation of a National Park within which zones would be selected for specific purposes. The National Park would be administered by a body having sufficiently broad responsibility management autonomy to enable it to resolve the special problems peculiar to Petra. As one comes to the end of the Siq, the first and the greatest monument of Petra slowly comes into view (see Fig. 3^[1]). This is the famous Treasury monument. Along the walls of the Siq are many small niches containing block gods of various kinds, Fig. 2(b)^[6].

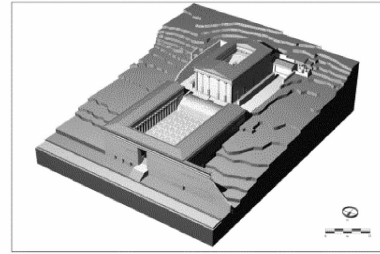
Fig. 4 Reconstruction of the temple

vention, the reversibility of any chemicals and materials used in consolidation, and the use of new stone which is discernible from the ancient ashlar, exercising great care, the project uses modern technology (virtual reality exploration), straps, cranes and front loaders (see Fig. 4).

The Petra Great Temple Reconstruction
Brown University Excavation

Phase VII

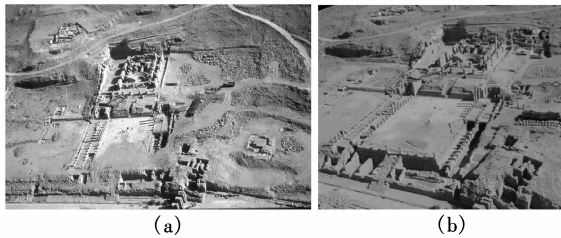
Fig. 5 The Great Temple. (a) Before reconstruction; (b) After reconstruction

Archaeological investigations of ancient structures of any kind are important in increasing our knowledge of the past; however, they also produce serious side effects by exposing structures to the elements and vastly increasing the rate of decay. In order to slow this process, we have employed certain measures simultaneously with the excavation. With this in mind, a preliminary conservation survey of the excavated portions of the Temple, at present, has been carried out with a view to preserving and restoring various architectural features. From the beginning, the fundamental philosophy of the Great Temple excavations has been the consolidation of the site and the re-erection of columns while the excavations are in progress. Exposure of the architectural features has been of serious concern, since the site is susceptible to erosive heavy rains and earth tremors. This was acknowledged by the incorporation of several additional consolidation procedures which have become part of our research design. An application was made to the World Monuments Fund which granted an award expressly for site preservation, conservation and consolidation. The Great Temple Consolidation Project was made possible in part by a grant from the Samuel H. Kress Foundation through World Monuments Watch, a program of the World Monuments Fund. Briefly described, budget constraints forced us to be selective in what we could undertake. While portable artifacts were photographed on site, architectural components were removed to the lapidary to the west of the site, after these artifacts had been fully documented. The artifacts for the catalogue were deposited with the Department of Antiquities in Petra, and the remaining artifacts and smaller architectural fragments were registered and boxed on site and reburied (see Fig. 5).

Now that all the temple columns have been located, their reversible re-erection has been undertaken. Using a tested mortar which in composition is similar to the original Nabataean mortar also has consolidated architectural elements that have been imperiled both from 2000 years of erosion as well as by recent excavations.

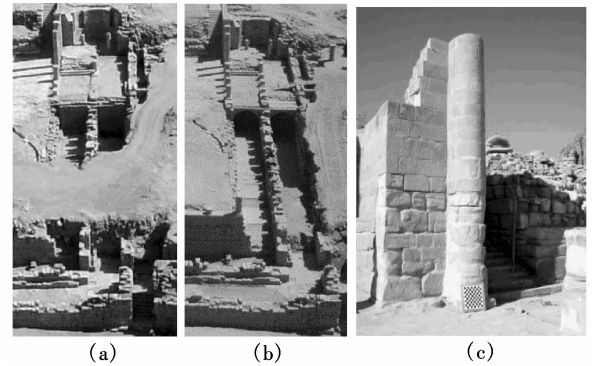
Fig. 6 Lower Temenos. (a) Lower Temenos West Cryptoporticus before excavation and reconstruction; (b) Lower Temenos West Cryptoporticus after excavation and reconstruction; (c) The East Exedra Engaged Column, re-erected

Gaps along the eastern portion of the walls have been filled with mud mortar and small stone wedges. The face of the walls has been treated by pointing with mud mortar and stone wedges. Gaps occurring between the column drums have been treated either by removing and re-placing the drums or by injecting mud mortar (grouting) between them. The drainage channel in front of the West Exedra has been covered with sand and has been backfilled. The east wall of the West Exedra has had the blocks removed and replaced, and this wall has been stabilized. The top of the West Exedra wall has been pointed (see Fig. 6).
