# Experimental study on the durability of BFRP bars embedded in concrete

**Abstract:** This paper presents an experimental study on the alkali-resistant properties of basalt fiber reinforced polymers (BFRP) bars under a typical concrete environment. BFRP bars were embedded in concrete and exposed to different aggressive environments, including tap water, saline solution and ambient temperature environments, to study the effects of the type of solution and relative humidity (RH) on the durability of BFRP. Meanwhile, BFRP bars were directly immersed in an alkaline solution for comparison. The acceleration factor describing the relationship between the alkaline solution immersion and the moisture-saturated concrete was also obtained. Aging was accelerated with a temperature of 60 °C. The results show that the chloridion in the saline solution does not have any harmful effects on the degradation of the concrete-encased BFRP bars. Contact with an alkaline (high pH) concrete pore-water solution is the primary reason for the degradation of the BFRP bars. The degradation rate of concrete-encased BFRP bars is accelerated when a high temperature and a high humidity are present simultaneousl

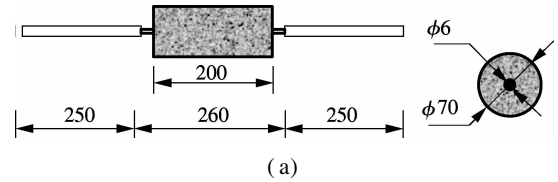
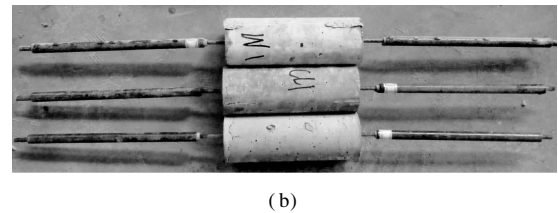
All the bars were cut into 760 mm in length, as specified by the ACI 440.3R—04 B2<sup>[16]</sup>, and were divided into two series: 1) Specimens without concrete case (5 unconditioned and 20 immersed in alkaline solution) and 2) Concrete-encased specimens (65 bars). The concrete was cast around only the middle 200 mm of the bars. The mold was a PVC pipe with an inner diameter of 70 mm. Therefore, the thickness of the cover concrete was 32 mm, which is commonly used in buildings. A layer of

waterproof epoxy resin was applied to both ends of the concrete cylinder and to the exposed BFRP. This ensures that the solutions permeated only through the circular side surface. Each end was sand-blasted and placed in a 250 mm long steel tube grouted with an epoxy matrix to create grip ends for axial tension. The prepared concrete-encased specimens are shown in Fig. 1.

**Fig. 1** Specimens preparation. (a) Details and dimensions of concrete-encased specimens (unit: mm); (b) Specimens ready for immersion

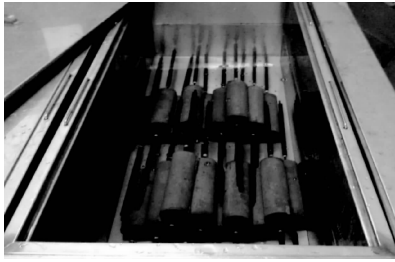
**Fig. 2** Specimens immersed in the temperature-controlled tank

For groups A, B and D, the temperature was controlled at 60 °C to accelerate the degradation effect of aging. 60 °C was lower than the glass transformation temperature  $T_g$  and was not intended to produce any thermal degradation mechanisms<sup>[18]</sup>. The test program started at the beginning of August and finished at the beginning of April of the following year. Thus, the ambient temperature for groups C and E was the temperature in Nanjing, China during the period from August to March (temperatures ranged from −6 to 39 °C). After each period, the concrete wrap was carefully removed from the middle of each concrete-encased specimen using a pressure testing machine to avoid any additional damage.

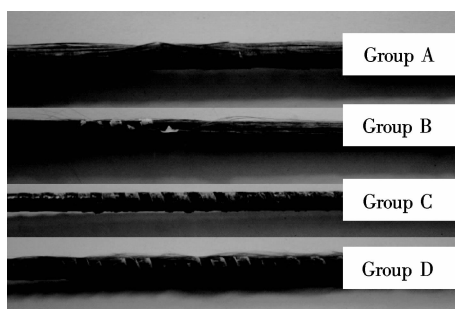
The original BFRP bar was black in color. After exposure, groups A, B and D's BFRP bars changed from the original black to gold, which is similar to the color of the basalt fibers themselves. This change suggests that the bonding of the resin and fibers was damaged during the corrosion. The surface appearances of specimens after 30 d of corrosion are shown in Fig. 3. Loose fibers were observed on the surface of groups A, B and D, and as the

**Fig. 3** Appearance of BFRP bars after 30 d in different environments

corrosion continued, surfaces in group D became looser, whereas surfaces in groups A and B were unchanged because of the confinement of the concrete. There were no obvious changes to the surface color and configuration of group C specimens.

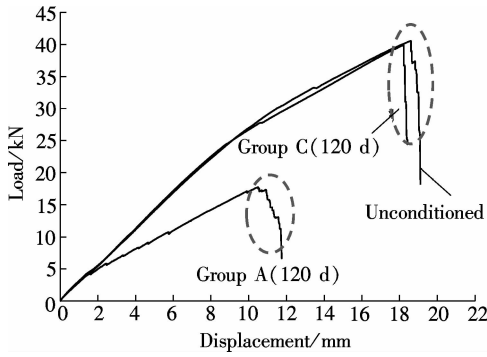
Fig. 5 shows typical load-displacement curves for both the unconditioned and conditioned bars from groups A and C after 120 d of exposure. The load-displacement curve of group C was almost coincident with that of the unconditioned BFRP bar with the exception of some degradation of the ultimate tensile strength. The group A's curve was clearly different from the other two. From the curves, it was found that the failures of unconditioned and group C specimens were catastrophic with a sudden load decline, whereas the declining group A curve was gentler compared to the others.

**Fig. 5** Typical load-displacement curves of conditioned and unconditioned BFRP bars

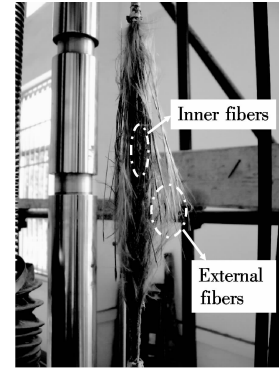
Fig. 6 shows the typical failure mode of the group A BFRP bars after 120 d of exposure. It was observed that the outer fibers were gold in color without any resin attachment, and the inner fibers remained black in color with resin attached, revealing that the corrosion of the FRP bars occurred, starting from the outside to the inside

**Fig. 6** Typical failure mode of BFRP bar of group A (120 d exposure)

gradually. During the tensile test of group A specimens, the external exposed fibers bulged and were fluffed out constantly with little noise and the fibers ruptured from the outer to the inner layers gradually. Moreover, slight

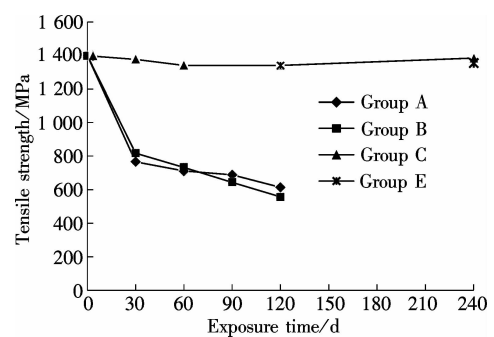
As shown in Fig. 7, group A and B specimens showed an obvious tensile strength degradation after 30 d conditioning at 60 °C. The BFRP bars experienced 45.2% and 41.6% reductions in tensile strength, respectively. However, only a 1.5% reduction was observed for group C specimens. In groups A and B, the degradation rate obviously decreased with the duration of immersion. Similar

**Fig. 7** Tensile strength of BFRP bars embedded in concrete

of group C BFRP bars was observed for as long as 240 d. The observed slight reduction in tensile strength (less than 5%) may have been caused by damage during the concrete crush or because of the discreteness of the material. According to the experimental investigation, it can be concluded that BFRP bars embedded in concrete and placed indoors possess excellent durability performance.

The group A specimens were immersed in tap water, whereas the group B specimens were immersed in a saline solution. The degradation trends shown in Fig. 7 indicate that there are no significant differences in the decrease in tensile strength of the concrete-encased BFRP bars whether immersed in tap water or salt solution. This conclusion was consistent with the primary experimental results of Robert et al.<sup>[14]</sup> on GFRP bars. The chloride ion, which is harmful to a RC structure, has no additional adverse influence on the durability of BFRP bars. This provides a significant justification to use FRP bars as an alternative to steel bars, particularly within marine structures.

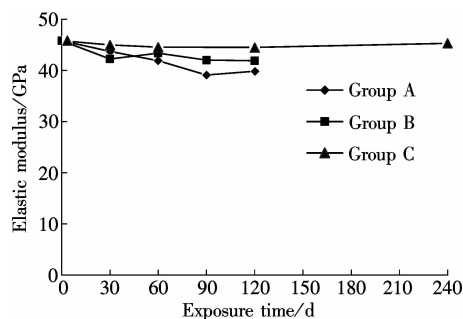
Fig. 8 shows the change in the elastic modulus for groups A, B and C. It can be observed that the loss in elastic modulus in group C were negligible (less than 3%). In contrast, group A and B specimens displayed a slightly larger decrease, ranging from 4.6% to 14.7%, and the coefficients of variation were also higher, as shown in Tab. 2. It should be noted that the elongation measured by the attached extensometer may have been affected by the serious loose surface, resulting in inaccurate data. Thus, the elastic modulus of group D was not measured.

Fig. 8 Elastic modulus of BFRP bars

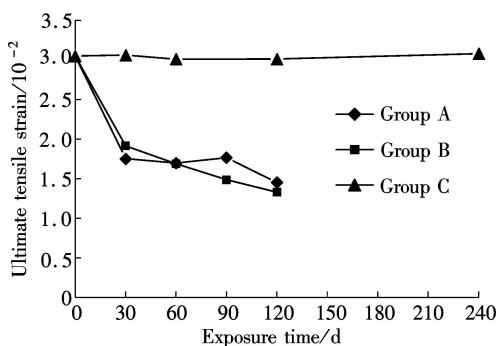
As shown in Fig. 9, the ultimate strain remained stable in group C, whereas a strain reduction trend was observed in groups A and B. The reduced ultimate strain trend was

Fig. 9 Ultimate tensile strain of BFRP bars

similar to the tensile strength trend because of the relatively constant tensile modulus.

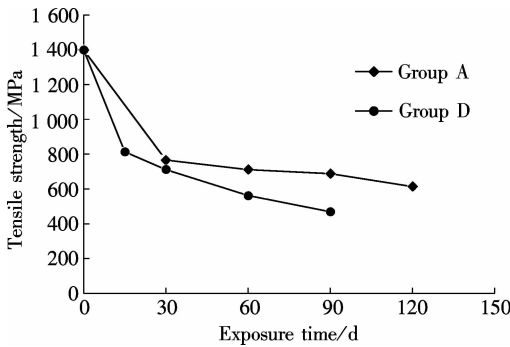
Bare BFRP bars from group D were immersed in a simulated concrete pore-water solution, whereas group A specimens were concrete-encased and immersed in tap water. As shown in Fig. 10, the tensile strength of BFRP bars in group A and group D exhibited similar down-trends, indicating that the degradation mechanism for BFRP bars in the two environments (alkaline solutions and moisture-saturated concrete (RH = 100%)) are the same. The strength loss in group D was higher than that in group A, which was 49.1% and 59.8% in group A and group D, respectively, after 60 d of immersion; was 50.8% and 66.5% in group A and group D, respectively, after 90 d of immersion. In a solid porous material such as concrete with a pore solution instead of free wa-

ter, alkali movements are, to some extent, restricted. Without the restriction of concrete encasement, direct immersion provides degradation acceleration in a moisture-saturated concrete environment.

Fig. 10 Tensile strength of BFRP bars

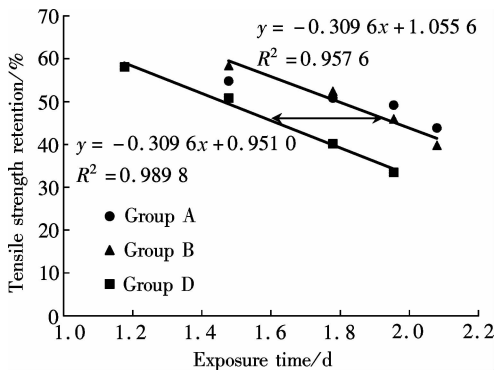
According to the most widely used degradation model for FRP bars presented by Bank et al.<sup>[11]</sup>, and adopted by Davalos et al.<sup>[19]</sup>, the shapes of the strength retention curves were approximated by straight lines based on a logarithmic time scale. The model was first developed by Litherland et al.<sup>[20]</sup> and was applied to predict the long-term performance of glass fiber concrete (GRC). As shown in Fig. 11, the two lines, representing concrete-encased (groups A and B) and bare (group D) specimens, are approximately parallel. However, the degradation rate of group D was accelerated because of the absence of a concrete wrap. In this case, the acceleration factor can be obtained from the distance between the curves. The calculation procedure is

$$\beta = \frac{t_w}{t_b} = 10^{\lg t_w - \lg t_b} \quad (1)$$

where  $\beta$  is the acceleration factor;  $t_w$  is the time for a concrete-encased specimen to reach a given degradation; and  $t_b$  is the time for a bare specimen to reach the same level of degradation. Comparison of the horizontal displacement

Fig. 11 Strength retention versus time for BFRP bar

of the curves gives an acceleration factor of about 2.18. That is, the degradation of 2.18 years of exposure in

moisture-saturated concrete results in the same loss of strength of BFRP as that of one year directly immersed in a simulated alkaline solution.
