Experimental study on axial compressive behaviors of prefabricated composite thermal insulation walls after single-side fire exposure

Abstract: The axial bearing capacity of prefabricated composite walls composed of inner and outer concrete wythes, expandable polystyrene (EPS) boards and steel sleeve connectors is investigated. An experimental study on the axial bearing capacity of four prefabricated composite walls after fire treatment is carried out. Two of the prefabricated composite walls are normal-temperature specimens, and the others are treated with fire. The damage modes and crack development are observed, and the axial bearing capacity, lateral deformation of the specimens, and the concrete and reinforcing bar strain are tested. The results show that the ultimate bearing capacity of specimens after a fire is less than that of normal-temperature specimens; when the insulation board thicknesses are 40 mm and 60 mm, the decrease amplitudes are 20.8% and 16.8%, respectively. The maximum lateral deformation of specimens after a fire is greater than that of normal-temperature specimens, and under the same level of load, the lateral deformation increases as the insulation board

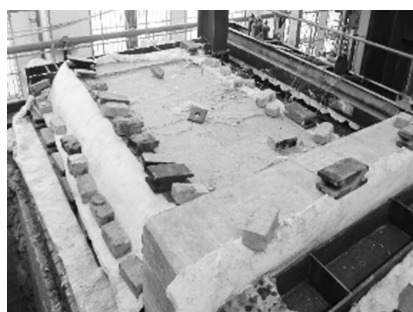
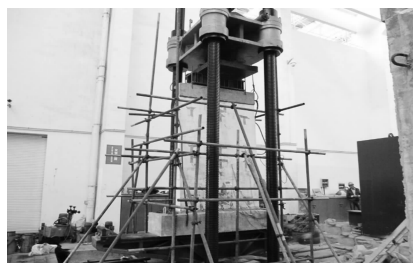
Fig. 3 Schematic of the heating and loading devices. (a) Heating device; (b) Loading device

Specimens DW2 and DW4 were placed horizontally in the fire furnace and exposed to fire on one side with no restraint applied to their other sides (see Figs. 3 (a)). When the exposure time (120 min) was reached, the furnace was closed while the ventilator circulated air until the temperature in the chamber dropped below $300\ ^\circ\text{C}$. Then, the heated walls were cooled in a natural environ-

ment. Afterwards, a vertical load was applied to the specimen via a hydraulic actuator (whose bearing capacity was 10 MN) fixed on a steel frame, as shown in Fig. 3 (b). A steel beam with a large rigidity was fixed to the top of the wall as a loading beam, which subjected the sandwich wall to a uniform load to avoid local crushing of the concrete at the top of the wall. Moreover, steel pipe scaffoldings were located around the specimen to prevent lateral instability and ensure the safety of the researchers

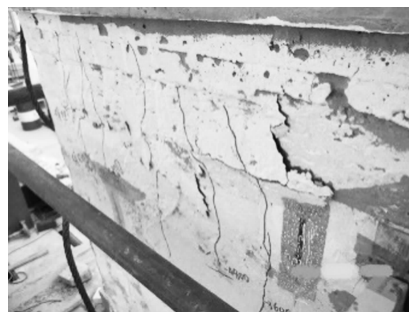
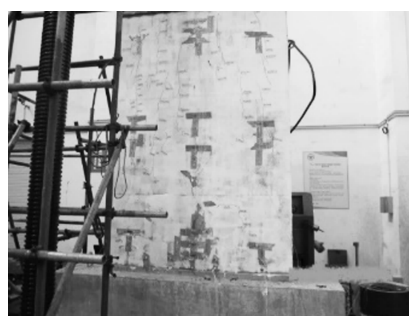
Fig. 4 Final crack patterns of specimen DW1. (a) Crack patterns and concretes crushed after loading; (b) Final crack patterns

For specimen DW1, which is a normal-temperature specimen with an insulation thickness of 40 mm, the first crack appeared in the top concrete beam under a load of 800 kN. Vertical cracks in the upper part of the wall occurred under a loading level of 2 000 kN. When the load reached 3 600 kN, vertically penetrating cracks were observed at both ends of the wall, and a number of transverse cracks were found at the top of the wall. With the increase in external loading, a number of new cracks appeared, and both the length and width of the original cracks became larger. The ultimate load was obtained when the out-of-plane displacement reached 25 mm with a corresponding load of 4 800 kN. From then on, the test was controlled by vertical displacement, and the applied load decreased with the increase in the out-of-plane displacement. The final crack patterns of specimen DW1 are shown in Figs. 4(a) and (b). Specimen DW1 failed due to concrete crushing in the top regions of the wall (see

Fig. 5(a)) with a load of 4 400 kN and a corresponding out-of-plane displacement of 35 mm.
