# Condition survey and analysis of epoxy asphalt concrete pavement on Second Nanjing Yangtze River Bridge: a ten-year review

**Abstract:** To obtain a complete picture of the epoxy asphalt pavement condition on the Second Nanjing Yangtze River Bridge, an on-site survey is conducted to collect information regarding traffic composition and extents of pavement distresses. The survey shows that 30 m<sup>2</sup> out of the entire 3.8 × 10<sup>4</sup> m<sup>2</sup> pavement exhibits potholes and alligator cracks. Other surface cracks are also found, including regular longitudinal cracks, short hairline cracks, bubble cracks, and ring cracks. Rutting and shoving are not observed on the pavement. The causes of pavement distresses are discussed by analyzing the pavement mechanical response with actual traffic composition. Research results indicate that the regular longitudinal cracks occurring at ribs near wheelpaths are due to fatigue damage. Short hair cracking and bubble cracking are mainly related to construction defects. Alligator cracks are the results of the development of regular, short hair and bubble cracks lacking effective maintenance. Potholes are induced by the cracking and m

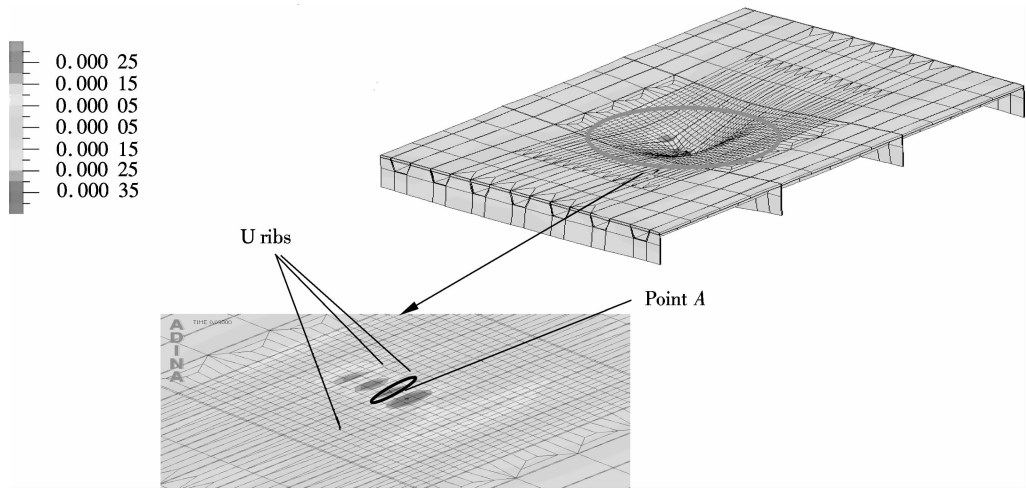
Fig. 12 3D FE model and local model for epoxy asphalt pavement on local orthotropic steel deck

Regular cracks are mostly fatigue cracks caused by repeated traffic loading. To investigate the mechanism of the initiation of regular cracks, a three-dimensional (3D) finite element model of epoxy asphalt pavement on a local orthotropic steel deck is established using the commercial software ADINA. An 8-node 3D solid element is selected to model the asphalt pavement and a shell element is used to model the steel bridge deck. Between the shell and solid elements, rigid links are adopted to make the pavement and

steel deck deform together. A sensitivity analysis of stress response is then conducted to determine the FE mesh size by reducing the size of the element gradually till the difference of the calculated stresses in two processes is within 5% [10]. As a result, areas around the critical stress positions such as ribs are meshed with fine element sizes, while regions located far away from critical stress positions are meshed with coarse element sizes. The final FE model, as shown in Fig. 12, includes 12 756 elements. According to the survey results of tire pressure, a standard tire pressure of 0.7 MPa, a 60% overloading tire pressure of 1.1 MPa, and a maximum tire pressure of 1.38 MPa are selected for computation. The maximum strains in the pavement at various temperatures and tire pressures are shown in Fig. 12. The FEM simulation results listed in Tab. 1 show that the maximum pavement strain occurs at the pavement surface on top of a stiffener of the orthotropic deck, as represented by point A in Fig. 12.

3) Regular longitudinal cracks in the pavement generally occur along U ribs or stiffeners, where the maximum strain or stress in the pavement is located. Short hairline cracks are caused by construction defects. Bubble cracks are caused by moisture contamination from water dripping from towers or cables or from worker sweat during the paving process, and are unique distresses in epoxy asphalt pavement on steel bridge decks. At a later stage, ring cracks may appear around the bubble cracks. If the above cracks are not timely and properly sealed, serious distresses such as potholes and alligator cracks can develop from these cracks under the coupling action of repeated traffic loading and dynamic water pressure.

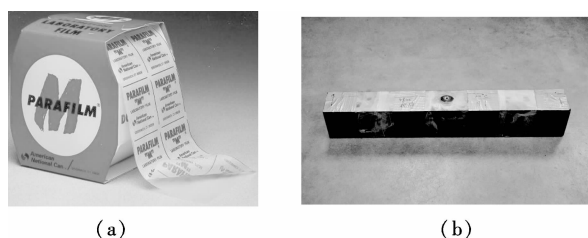
**Fig. 13** Parafilm M sheet and beam with moisture-conditioning.  
(a) Parafilm sheet; (b) Beam wrapped with sheet

will infiltrate the pavement. Under the coupling action of heavy truck loading and dynamic water pressure, potholes will eventually develop. To verify the detrimental effect of moisture on epoxy asphalt performance such as resistance to fatigue cracking, a strain-controlled four-point beam fatigue test was conducted on specimens conditioned with moisture. Such a test was designed to simulate the coupling of moisture and loading on the deterioration of epoxy asphalt pavement. The preconditioning procedure for moisture treatment was determined as follows: a specimen was first saturated in water at 635-mm-Hg vacuum for 30 min and then placed in a 60 °C water bath for 24 h. After that, the specimen was cooled to 20 °C and wrapped with Parafilm M, a moisture-resistant, thermoplastic flexible plastic sheet, to retain its internal moisture. Moisture loss during the fatigue test can be controlled within 1 g by Parafilm M. Pictures of Parafilm M and a beam wrapped with it are shown in Fig. 13.

The fatigue test was conducted in accordance to AASHTO T 321. Both dry and moisture conditioned specimens were tested for comparison. The air-void contents of all specimens were controlled under 3%, which was the same maximum value specified for the deck pavement on the SNYRB. Two test conditions, 600 microstrain at 10 °C and 900 microstrain at 20 °C, and a 10 Hz sinusoidal loading wave were selected to evaluate the mixture performance. The test results show the fatigue life of a moisture conditioned specimen at 10 °C is 169 182 cycles, which is about 1/6 of the fatigue life of 1 030 091 cycles of a dry specimen. The fatigue life of a moisture conditioned specimen at 20 °C is 466 899 cycles, which is around 3/5 of the fatigue life of 789 104 cycles of a dry specimen. It clearly shows that moisture conditioning reduced the fatigue life of the epoxy asphalt mixture. Therefore, moisture related damage should be noticed and further investigated in a future study.
